# Churchtown Conservation Area Appraisal and Management Plan

Draft for Consultation  
March 2025

Prepared by: **Growth**  
Lancashire Ltd

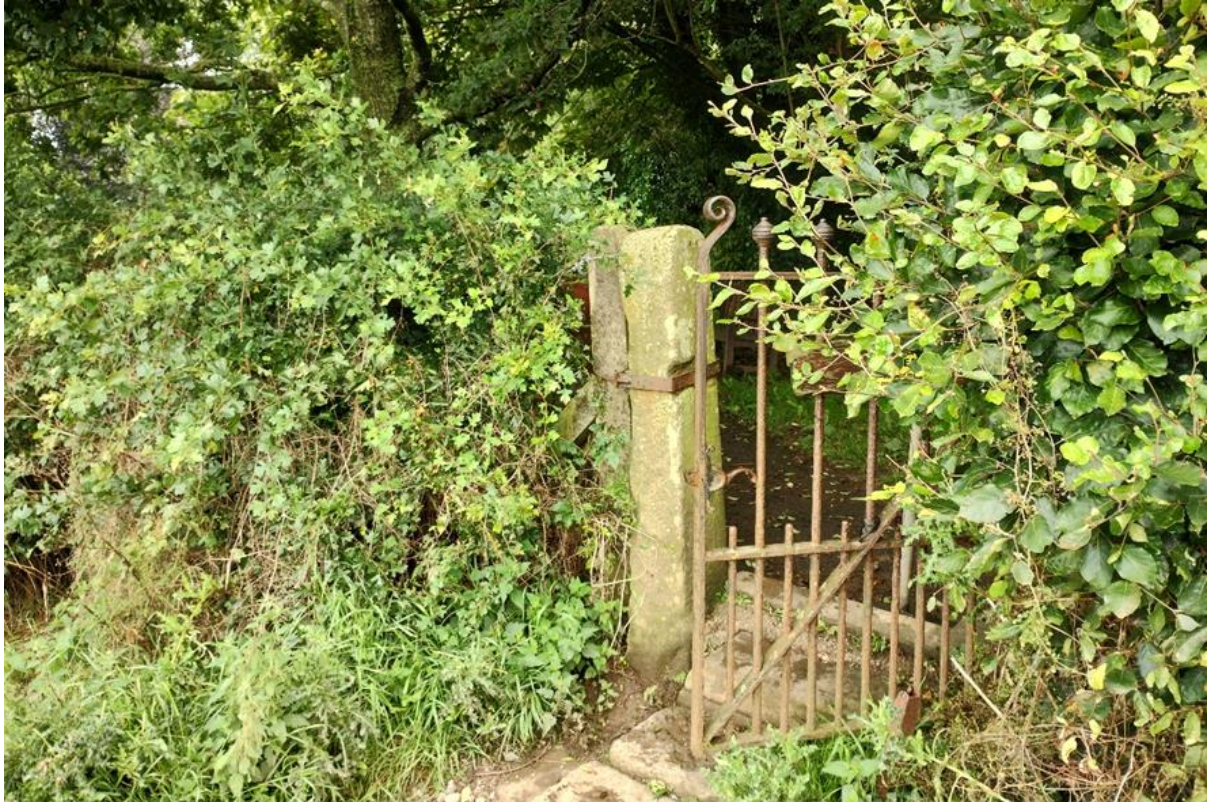
- 6.7.5 The low sandstone wall with triangular coping which encloses the churchyard and cast iron gate to the south of the church along the footpath.
- 6.7.6 The tall stone and brick wall which curves around the north entry to Church Street.

Figure 13: Cast and wrought iron gate to the footpath to the south of the churchyard

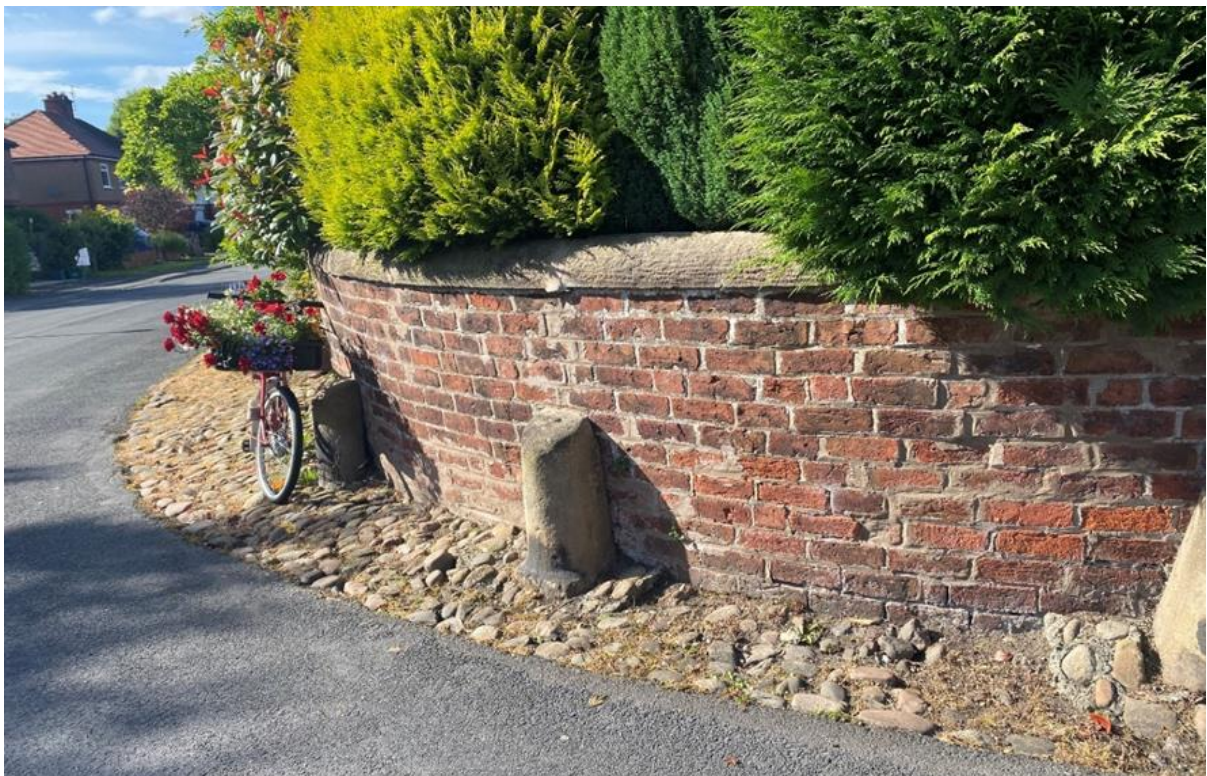
- 6.7.7 The brick wall that curves around the junction of Ainspool Lane and The Green with the three distinctive guard stones, complemented by cobbles.

Figure 14 Handmade brick boundary wall and guardstones complemented by cobbled paving at the junction of Ainspool and The Green

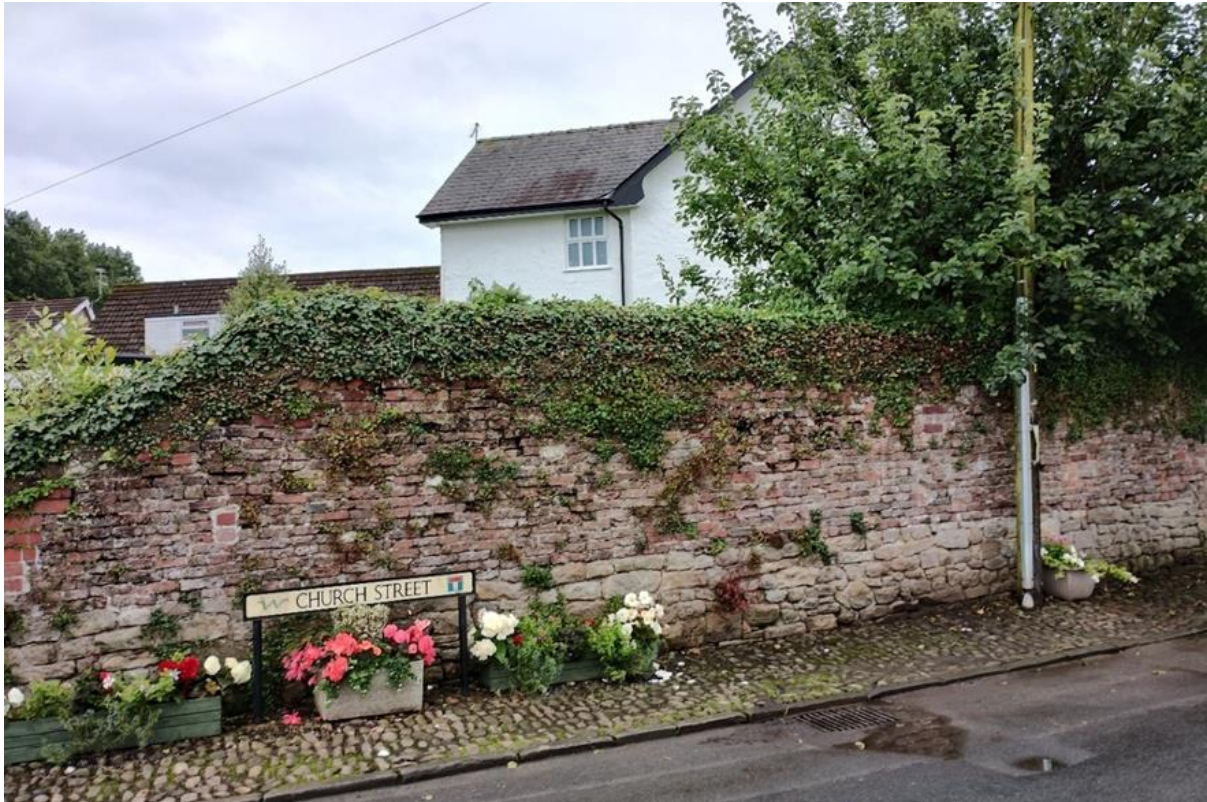
Figure 15 The stone and brick wall along Church Street complemented by cobbled paving

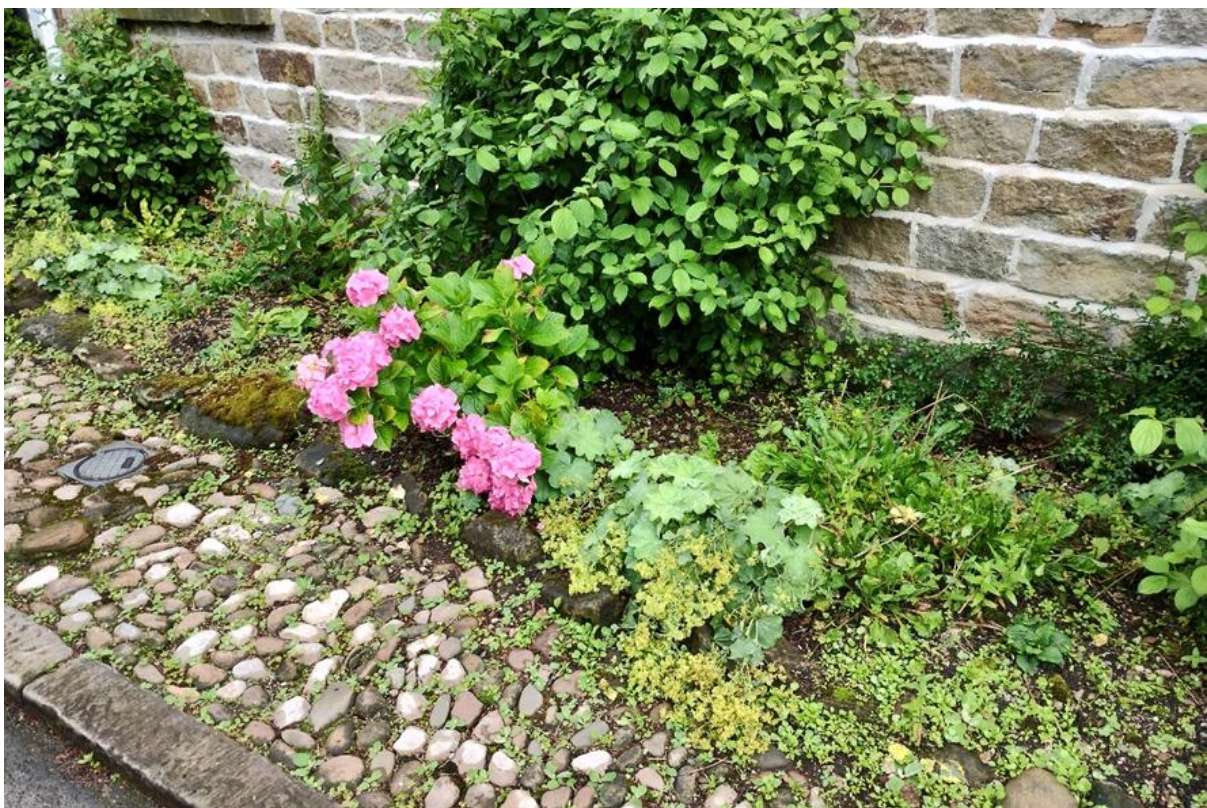
- 6.8.1 The consistent and well-preserved cobbled paving is a highly significant aspect of the conservation area providing visual framing to the historic buildings. Both sides of Church Street are almost entirely lined, with the exception of a parking area and the open area at the front of the churchyard. A short area of Ainspool Lane at the junction of The Green is also cobbled.
- 6.8.2 They are generally laid in rows perpendicular to the buildings, and are either finished with a contrasting line of cobbles or with hand cut sandstone kerbs.

Figure 16 Cobbled paving and stone kerbs

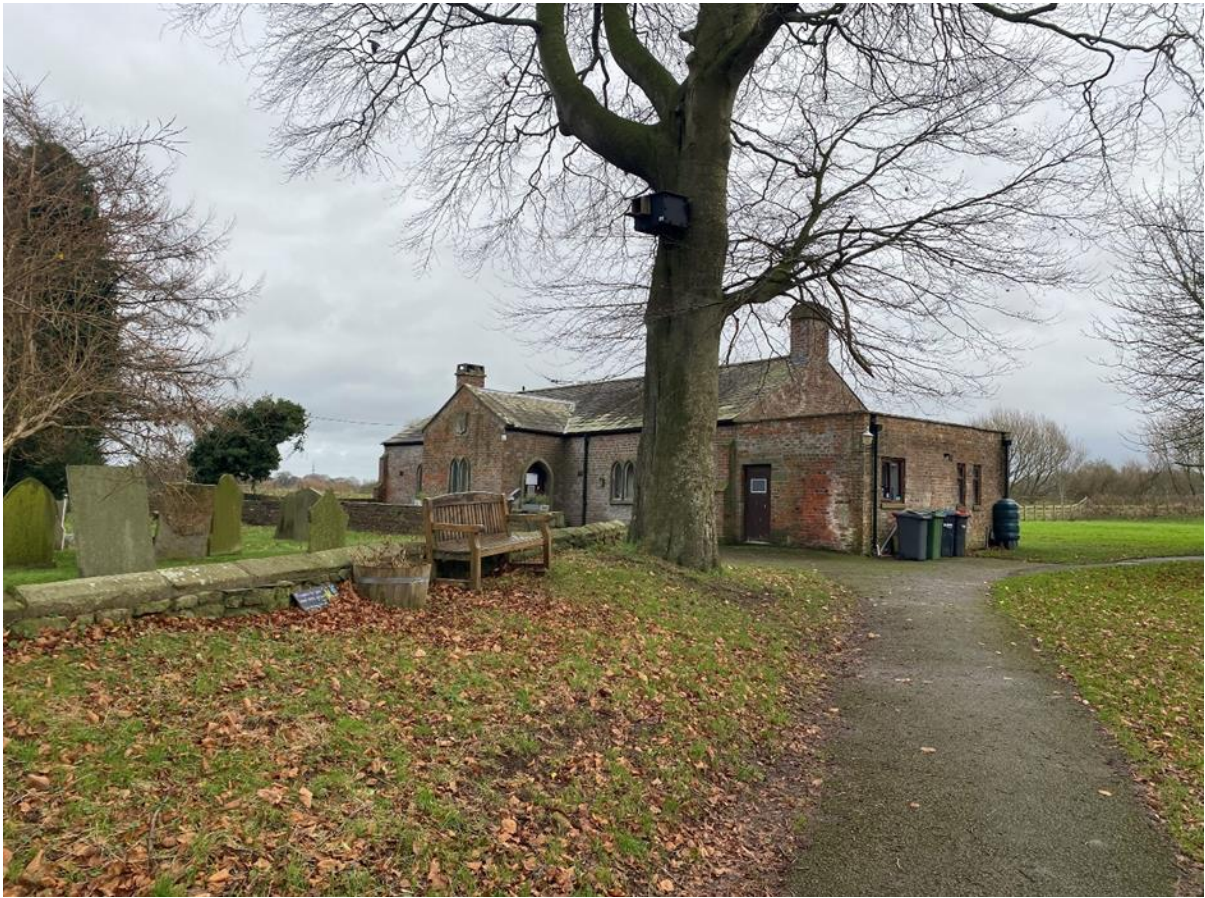
- 7.4.4 The Grade II listed Sunday School is an early-mid C19 brick building built beyond the churchyard wall to the south of the church. A single storey, gabled building of three bays with a central projecting gabled porch with doors in the return, windows are grouped in 2, 3 or 4 with stone architraves and lancet heads. The modern brick extension has disrupted its symmetry but it nevertheless retains its eclectic Tudor Gothic appearance derived from its soft red brick, projecting porch and lancet openings framed with stone. The open, verdant setting of the Sunday School adds to its character and reflects its historic surroundings.

Figure 19: The Sunday School

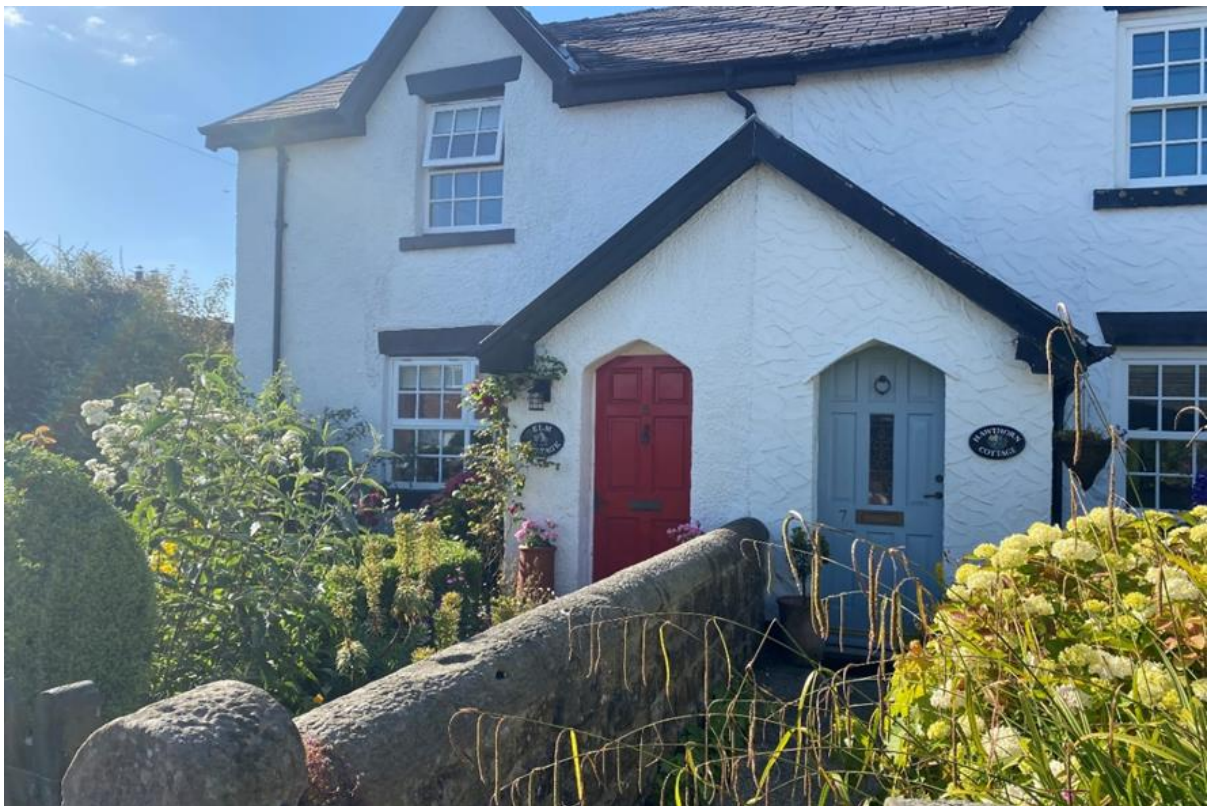
Figure 21: Stone and brick boundary walls and front gardens emphasise the relationship between the house and the garden

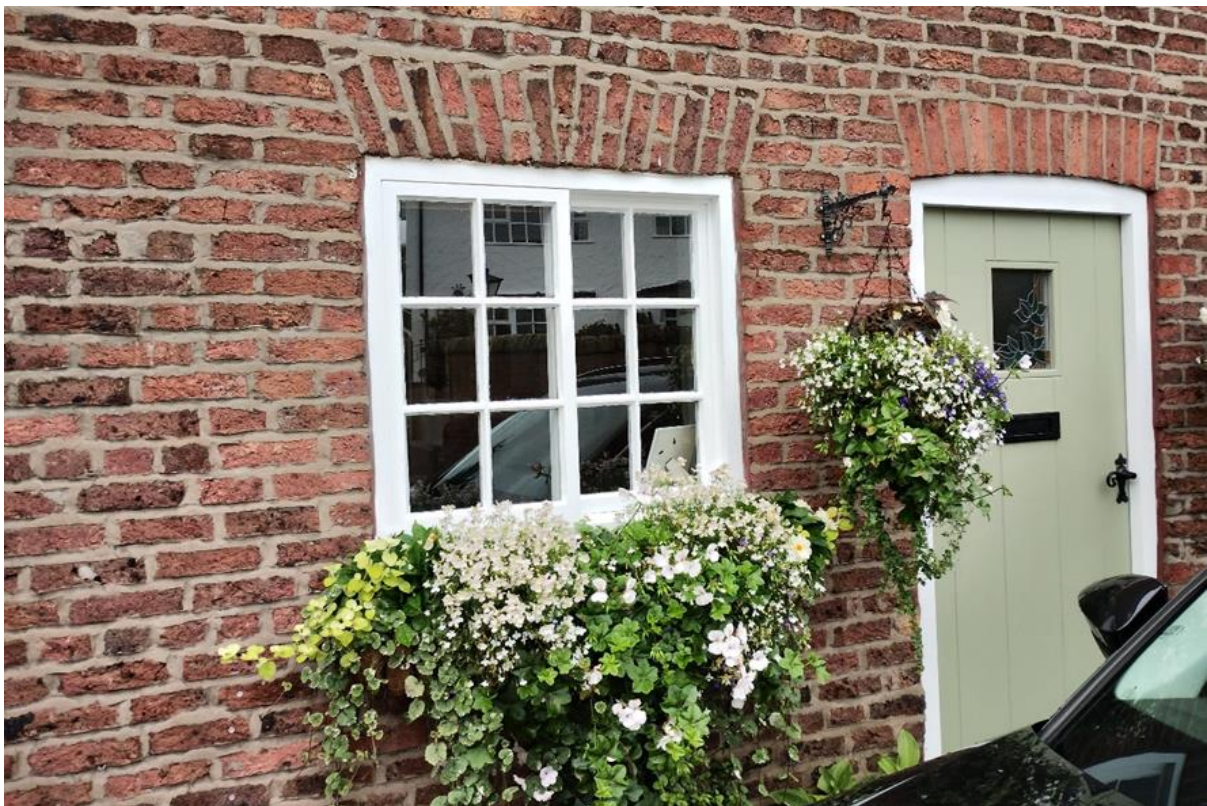
Figure 23 A Yorkshire sliding sash
