# Scorton Conservation Area Appraisal and Management Plan

Draft for Consultation  
March 2025

Prepared by: **Growth**  
Lancashire Ltd

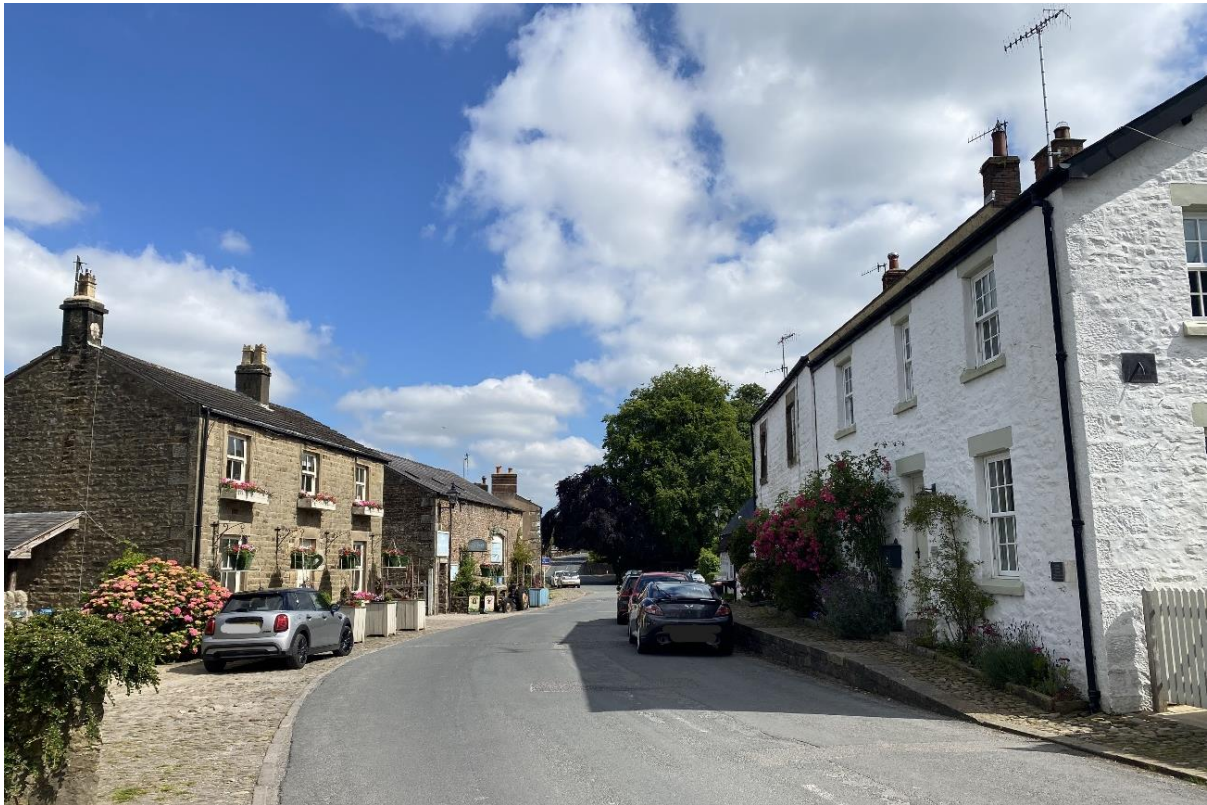
- A nucleated settlement dating to at least the sixteenth century.
- Linear historic development along the arterial streets leading to the open space of The Square, forming a pleasing spatial contrast.

Figure 1: Linear development along arterial routes leading into the open space of The Square

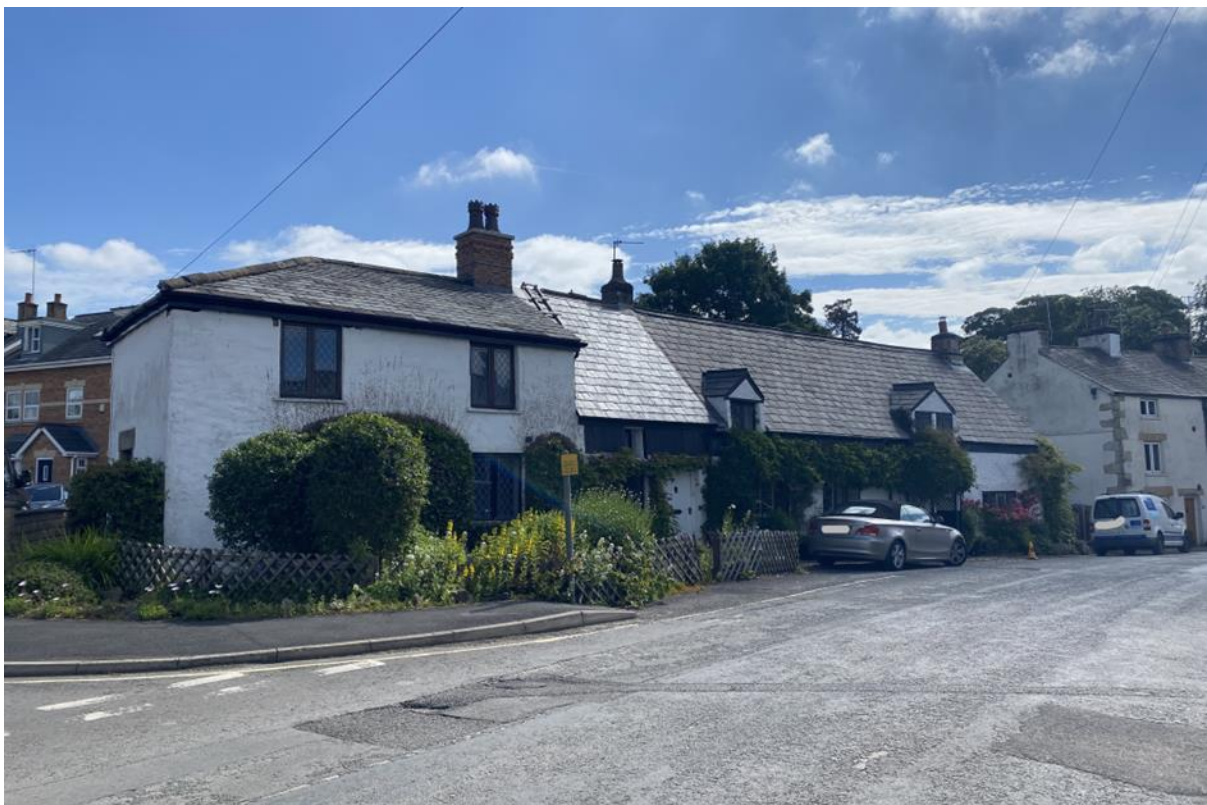
- A high number of steeply pitched C17 and possibly earlier, Grade II listed formerly thatched cottages aligned parallel to the streets, complemented by well-preserved cobbled pavements, their pitches contrasting with later historic buildings, creating varied rooflines.

Figure 2: Varied rooflines

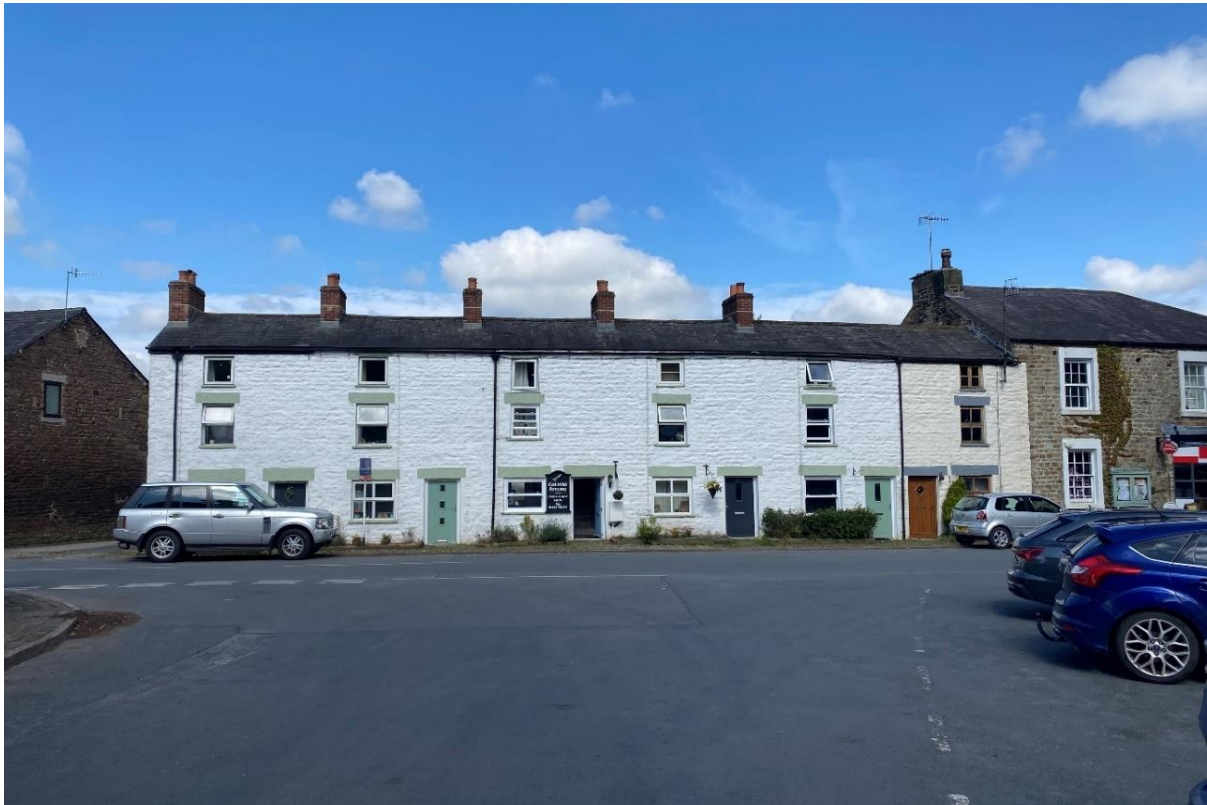
Figure 3: Uniform 18th century workers' cottages

- Uniformity created by the rows of three storey mill workers' cottages with simple lintels and unaltered openings to the front and rear, emphasising their verticality, and the village's Circa 18th century industrial expansion.

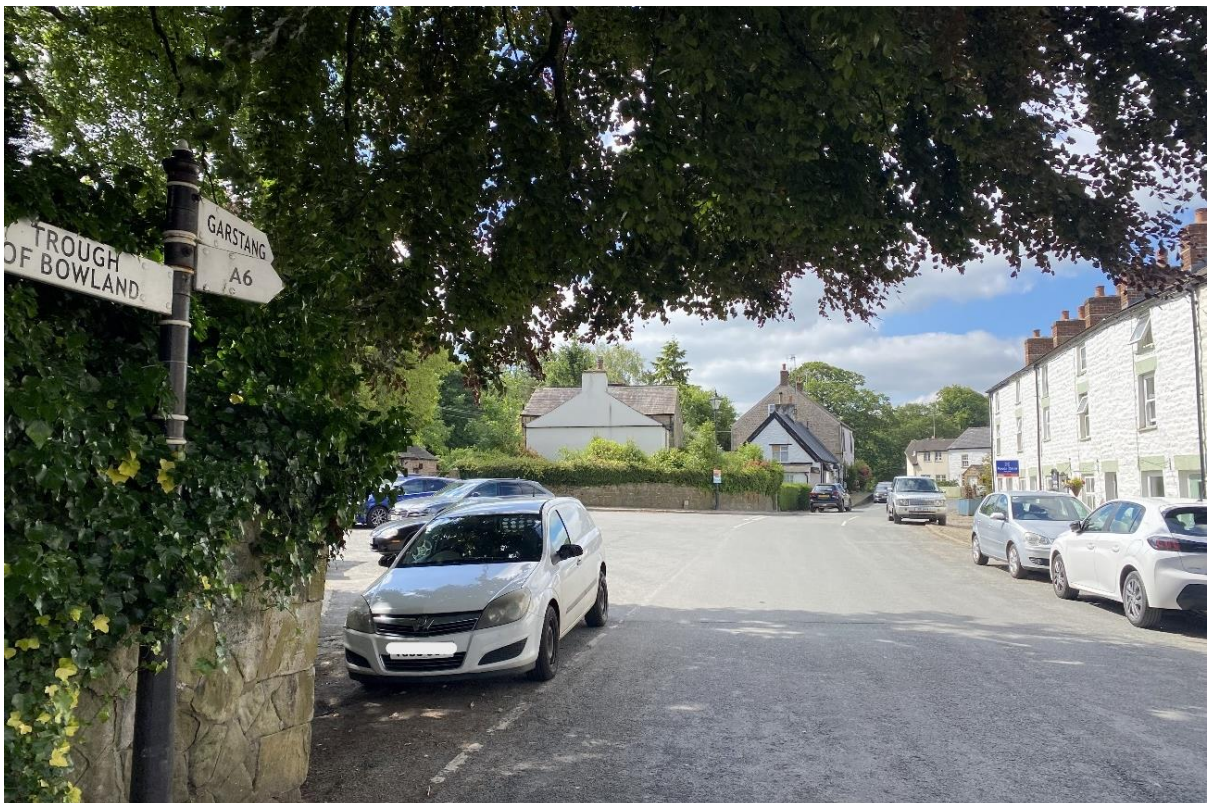
Figure 4: Enclosure created by walls, buildings and tree canopies

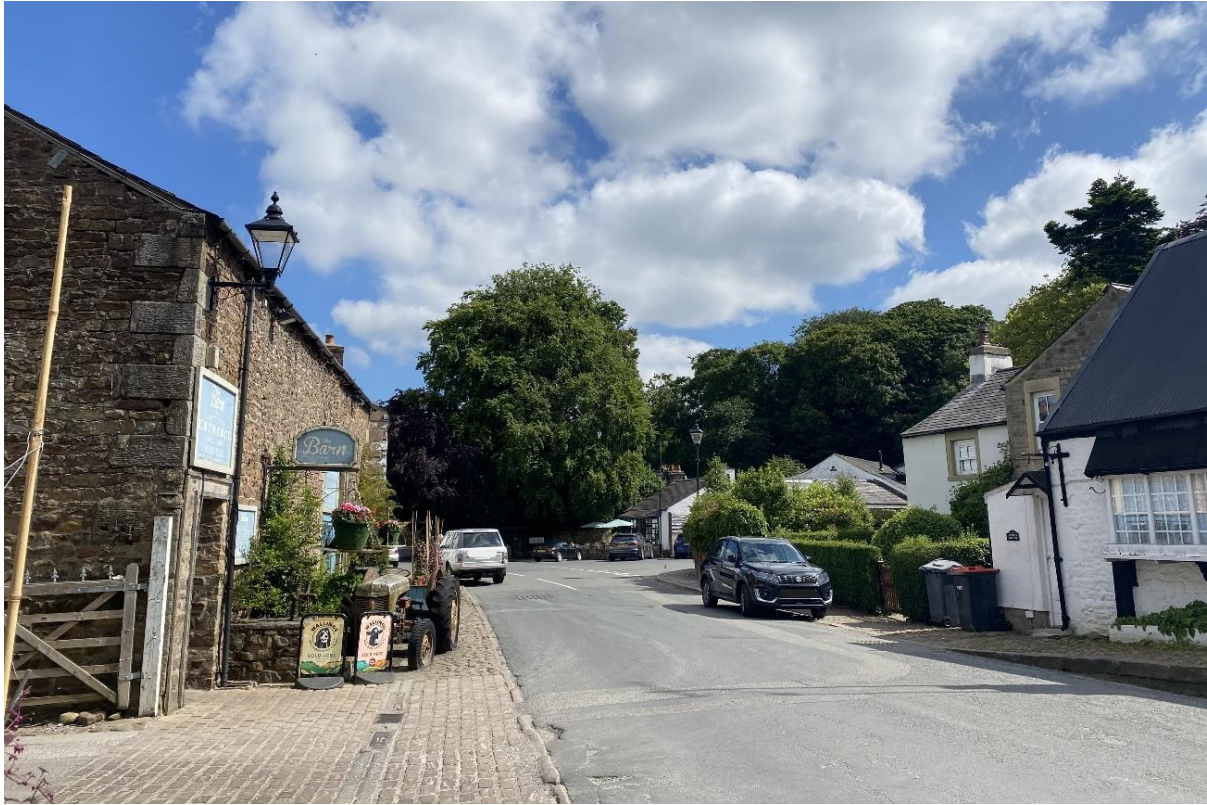
- 6.2.1 The Square where the roads converge provides the central focal point for the conservation area, allowing for appreciation of the spatial contrast between the open square and the surrounding linear development.
- 6.2.2 The Church of St Peter, with its tall spire and contrasting massing of the tower, set near the brow of a hill, complemented and framed by the extensive surrounding green space with a backdrop and foreground of notable trees, provides a strong focal point and entrance into the conservation area from the south.
- 6.2.3 The tall oak tree on the east side of Gubberford Lane approaching The Square. This is known as Stone Tree, and may be the site where Wesley preached. It frames views into the village centre.

Figure 5: The Square

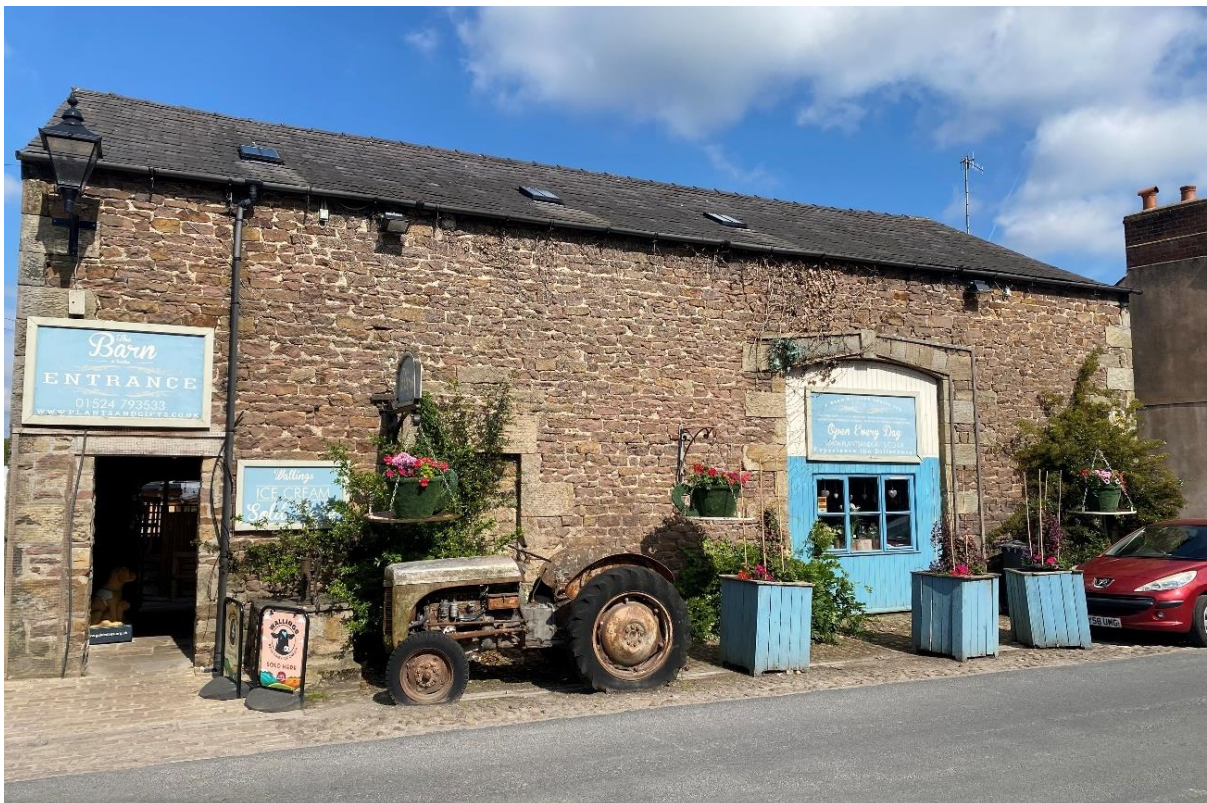
Figure 6: The Barn is a significant focal point in The Square

- 7.5.3 The Barn in The Square makes a particularly high contribution to the special interest of the conservation area with substantial massing and a deep square plan. It retains original, simple openings framed with fine tooled lintels and jambs. It forms a group with the other rectilinear farm buildings that create a U-shaped farmyard and reflects the importance of agriculture prior to Scorton's industrial expansion. Its contribution is heightened by its position at the back of the pavement, forming a contrast in scale and character with the surrounding houses.

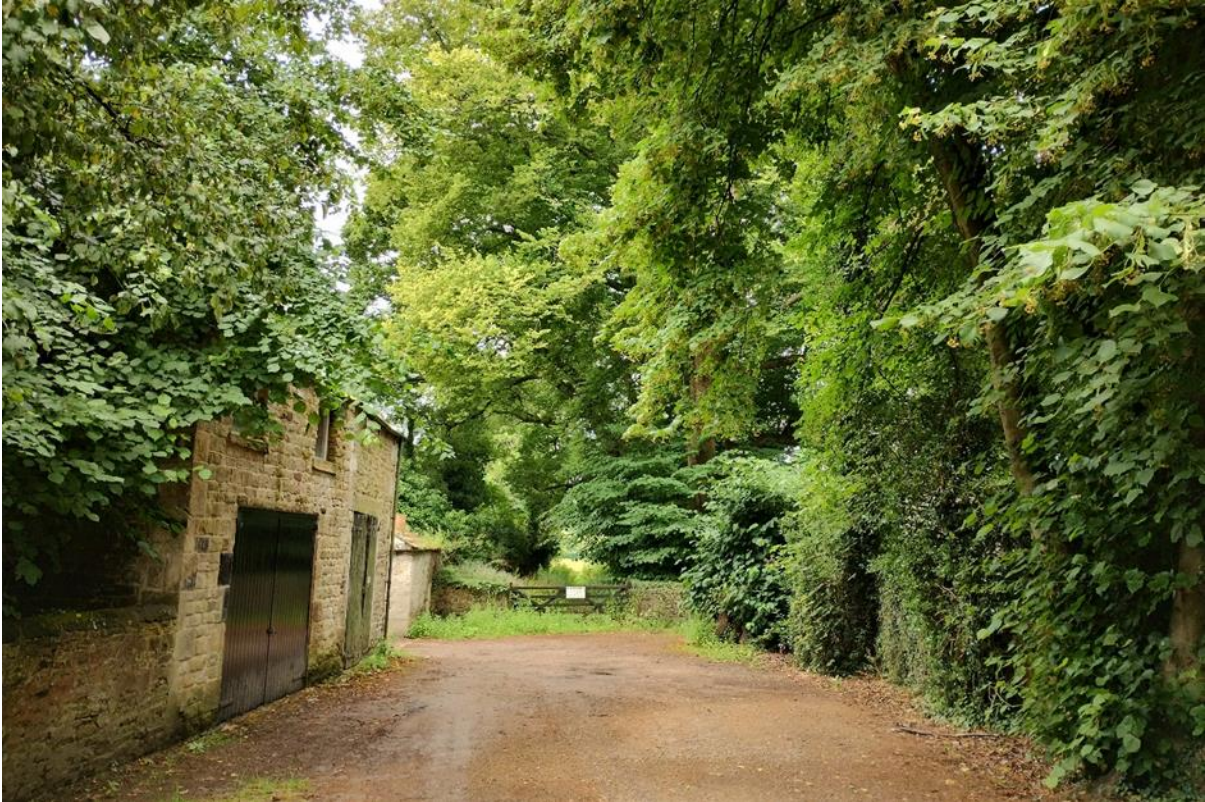
Figure 7: The view from Springfield House from Gubberford Lane

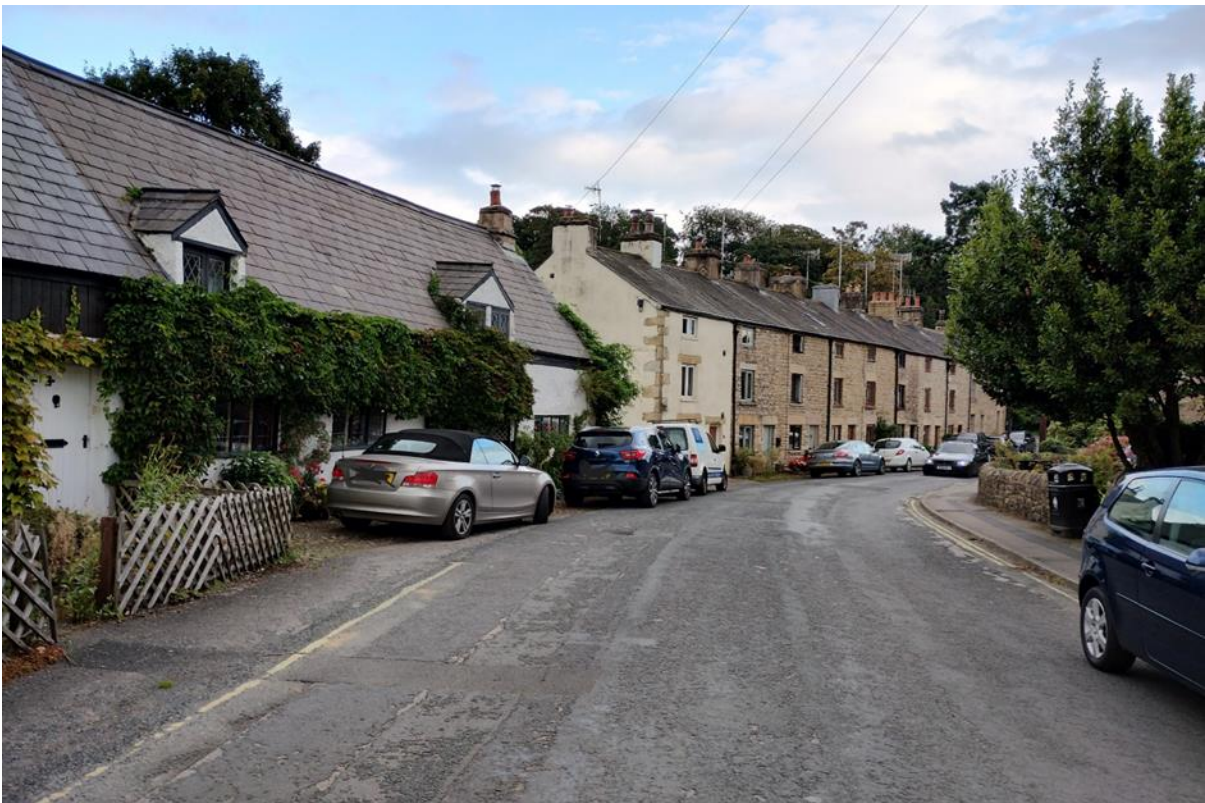
Figure 8: Station Lane with a backdrop of trees in the grounds of Wyresdale Hall

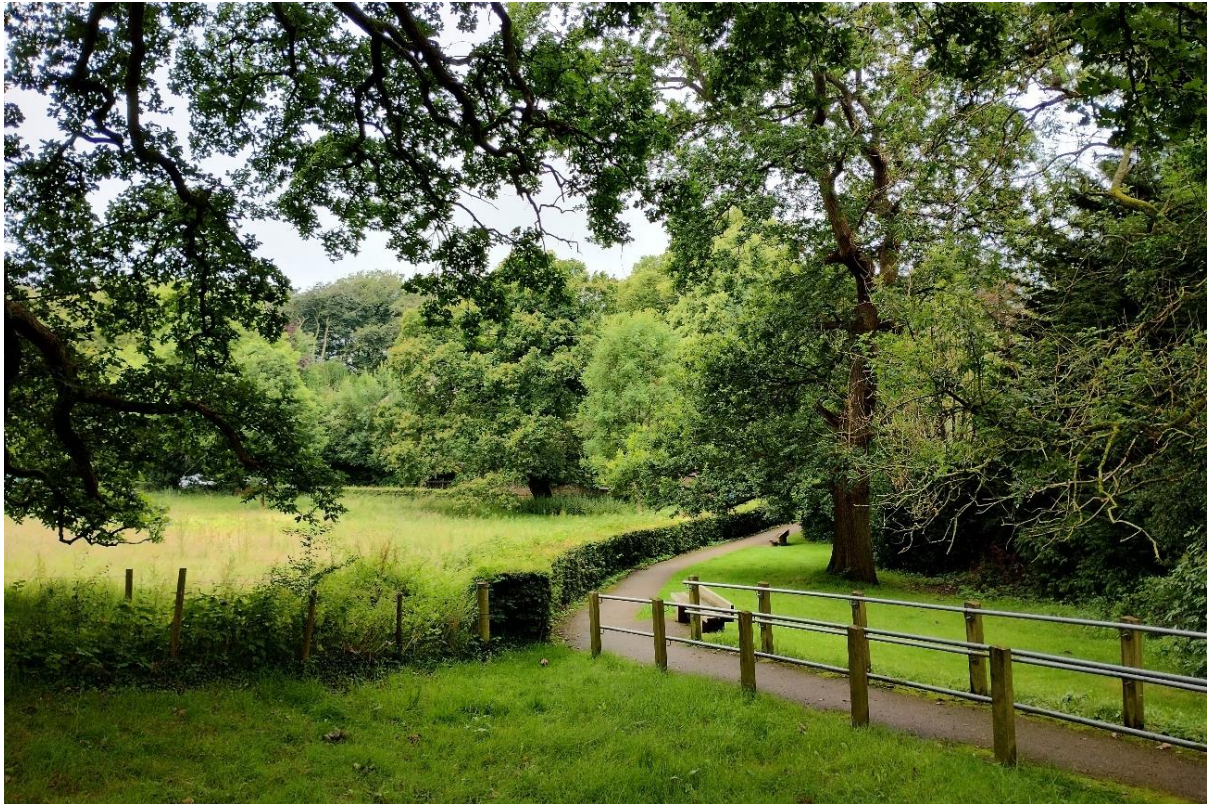
- 6.3.7 Views north and south along the path to the church of St Peter from Snowhill Lane, and from the churchyard facing west, make a major contribution to the special interest of the conservation area, providing a lush and leafy setting to the church.

Figure 9: Views from the churchyard of the Church of St Peter

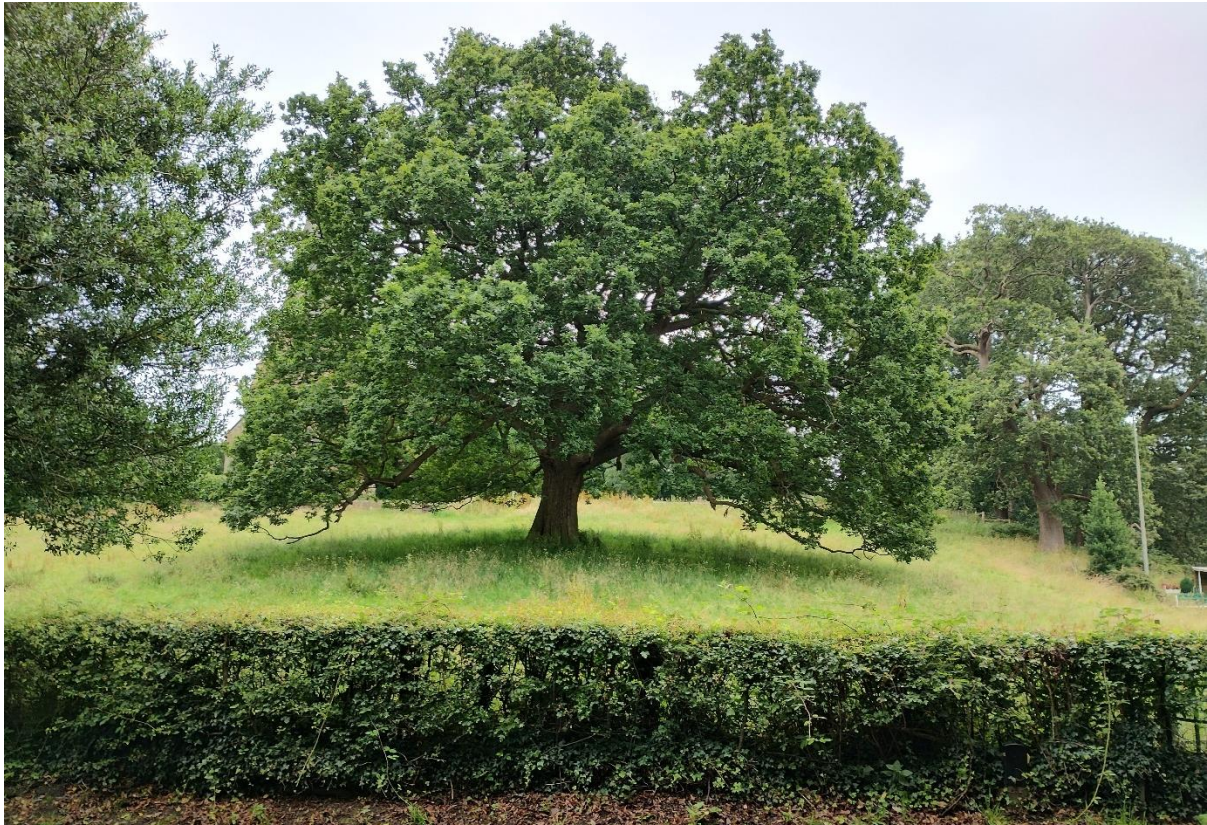
Figure 10: Oak in the grounds of the Church of St Peter

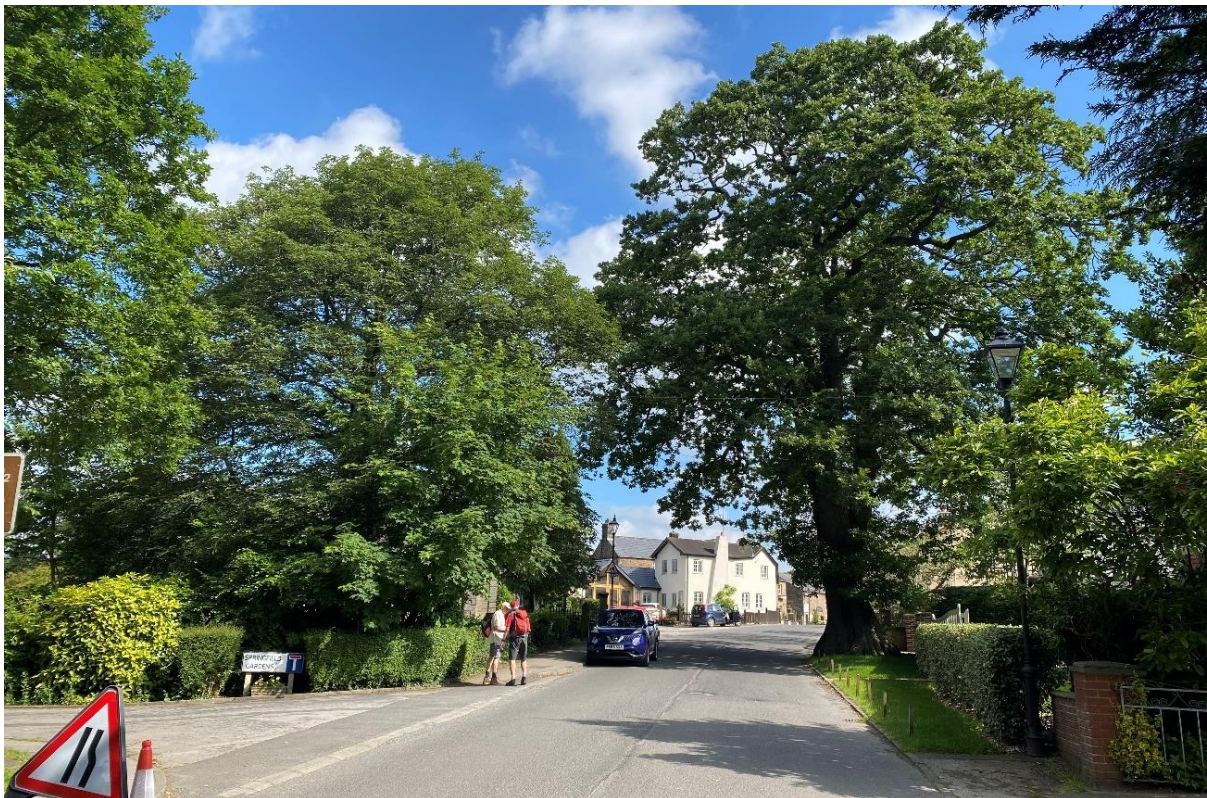
Figure 11: Oak on Gubberford Lane, known as Stone Tree (right).

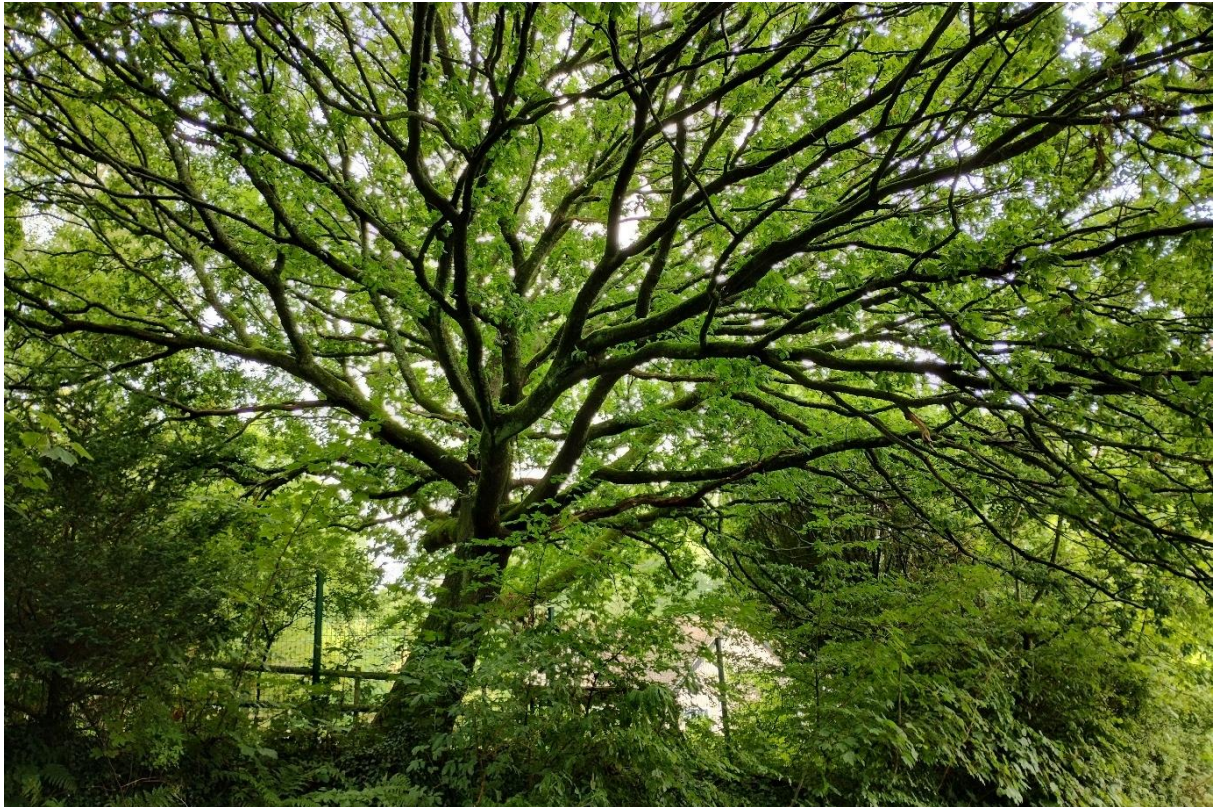
- 6.6.7 The green space on the south side of Snowhill Lane provides a further sense of enclosure with several trees with dense overhanging canopies.

Figure 12: Trees along Snowhill Lane contribute to the sense of enclosure

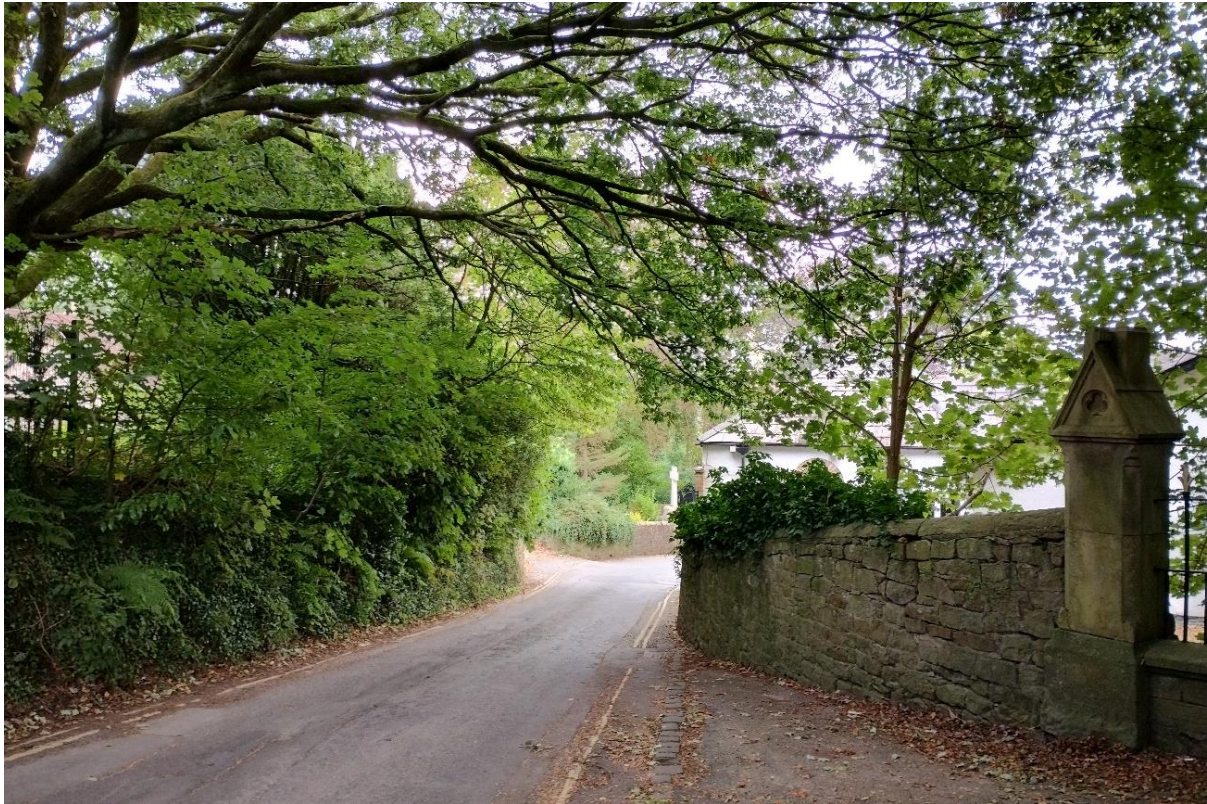
Figure 13: Sandstone walling enclosing Snowhill Lane

- 6.7.1 Sandstone boundary walls make a significant contribution to the character and appearance of the Scorton conservation area. These are typically tall and coursed, with semi-circular or triangular copings.

- 6.7.3 The sandstone wall to the south of The Square that encloses 30 The Square and continues along Snowhill Lane.
- 6.7.4 The Grade II listed walling and gate piers to the Presbytery on Snowhill Lane.

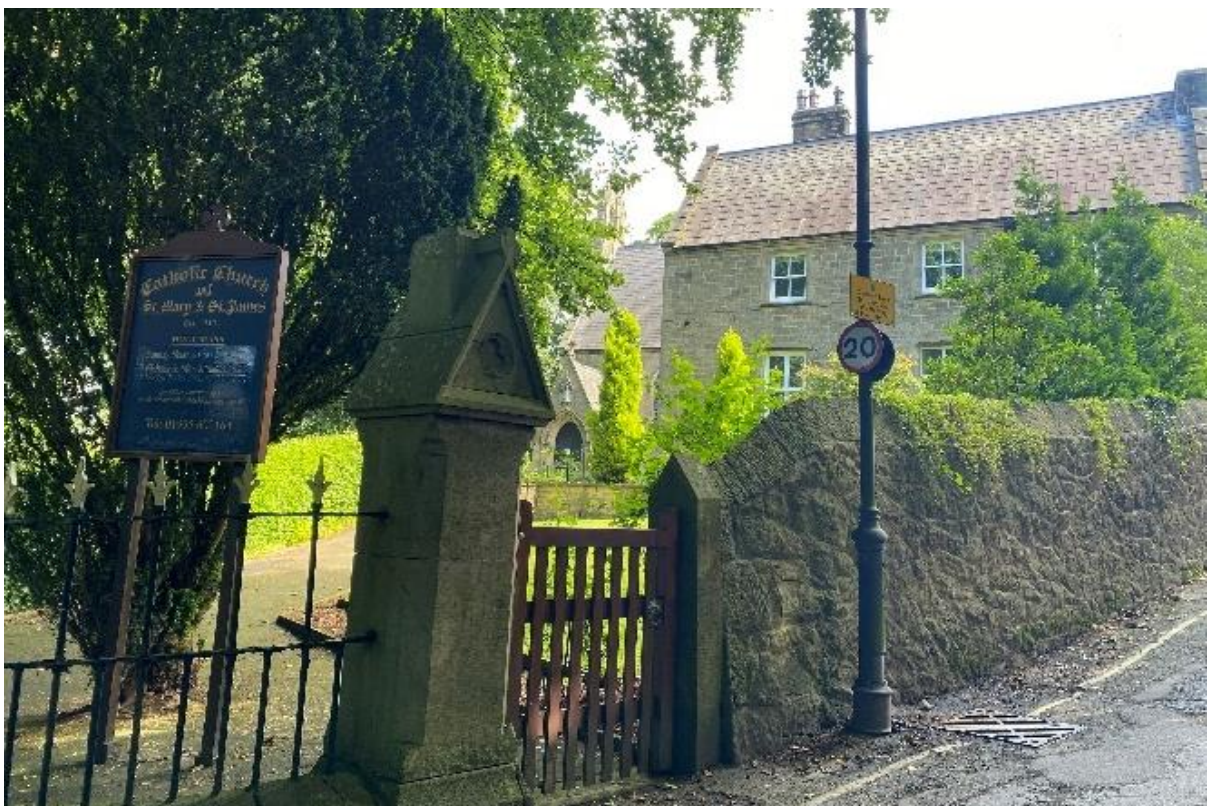
Figure 14: Stone gateposts and boundary walls to the Presbytery

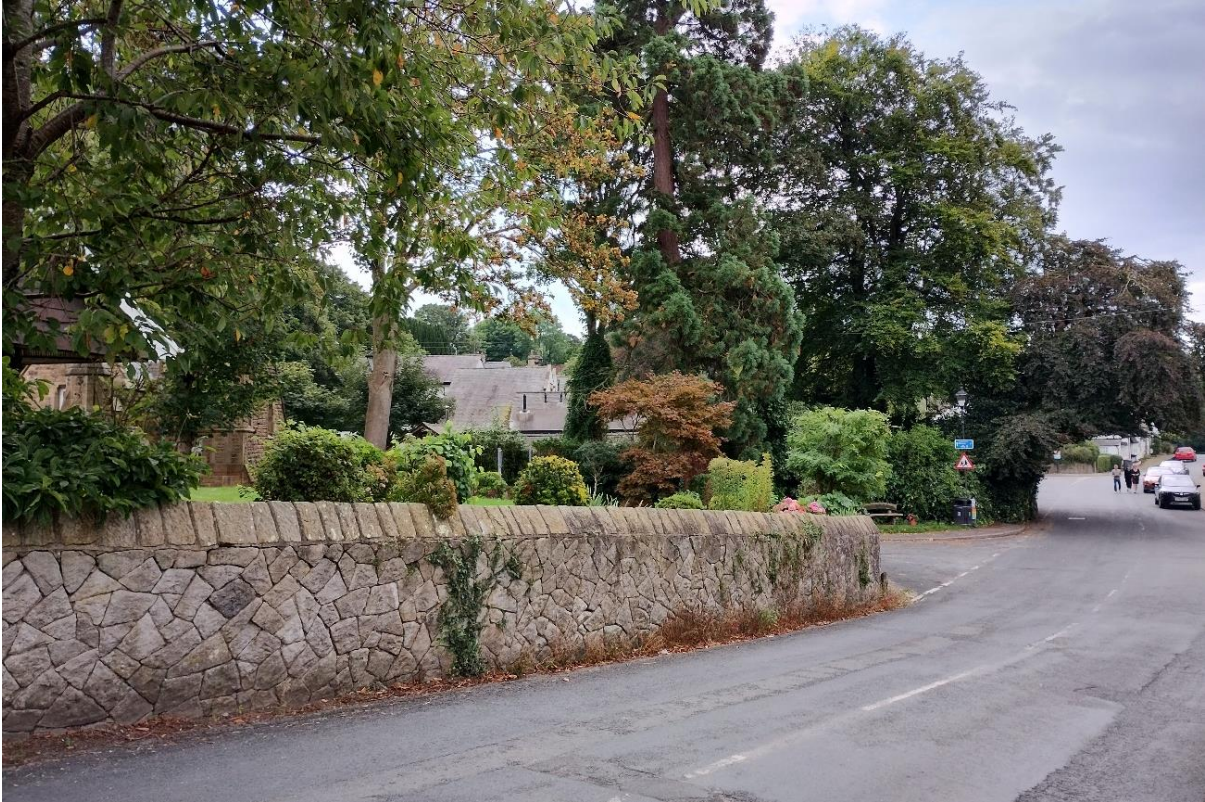
Figure 15: Stone walls provide a continuation of the building lines

- 6.1.4 19th century and earlier higher status cottages set back in verdant gardens bounded by stone walls and hedges.
- 6.1.5 Stone walls with triangular copings enclosing gardens and providing a visual continuation of the building line.

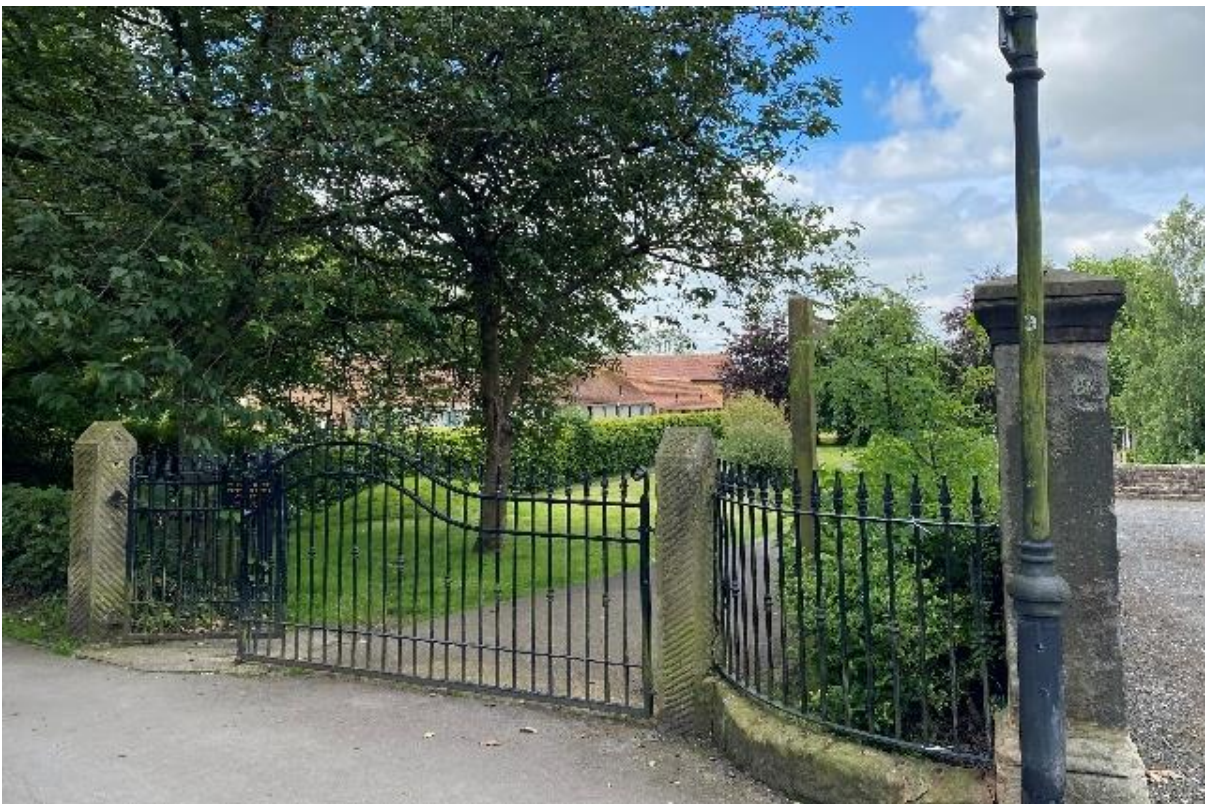
Figure 16: Walling enclosing the former entrance to Wyresdale Hall

- 6.7.6 Sandstone walling enclosing the former entrance to Wyresdale Hall either side of Scorton Hall Park, enhanced by tall trees.
- 6.7.7 The sandstone walling to properties along Gubberford Lane which provide a sense of enclosure enhanced by the presence of tall trees and verdant gardens.
- 6.7.8 Gateposts enclosing the park adjacent to the Methodist Chapel.

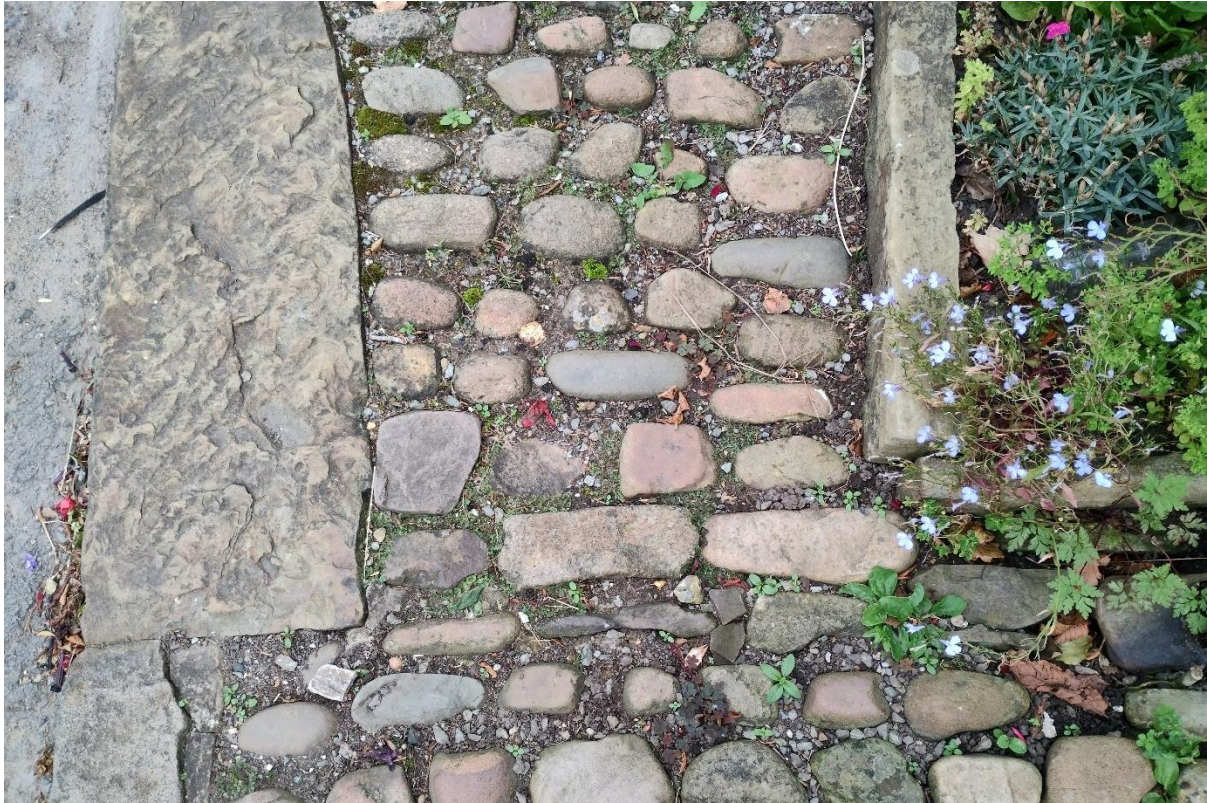
Figure 17: Detail of a preserved cobble pavement, kerb edging and adjacent planting

- 6.8.1 One of the most important aspects of the conservation area is the consistent presence of historic and well-preserved cobbled paving, particularly around buildings surrounding The Square. The cobbles are usually bounded by substantial sandstone slabs forming kerbs. This provides visual framing to a number of historic buildings and adds aesthetic interest to the conservation area as a whole. Significant sections of the village remain cobbled, but some later replacement is generally with granite setts rather than cobbles.
- 6.8.2 On the west side of The Square, a section of river cobbles is preserved in rows laid horizontally which continues almost the whole length of the road until Station Lane. Sections are preserved under C20 concrete slab, and it is likely further cobbles remain under modern paving.

- 9.3.4 It would be beneficial if cobbled paving could be reinstated to replace modern pavement in poor condition, with consideration of a maintenance agreement with relevant stakeholders for its future upkeep. This would greatly enhance the appearance of the conservation area. Should this be feasible, where a patchwork of repairs is evident, a stock of more appropriate cobbles to be used as and when repair takes place through agreement with statutory undertakers, could be investigated, subject to funding.

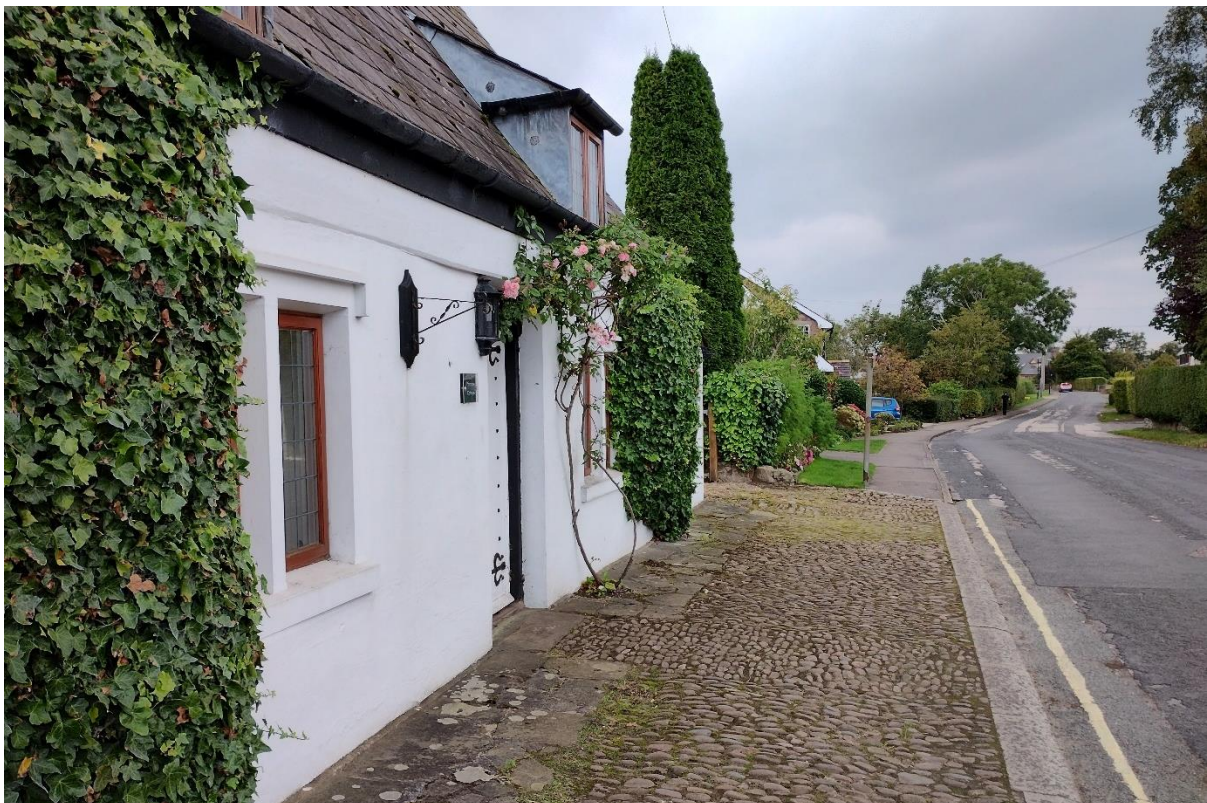
Figure 18: Preserved historic cobbles contribute to the character of the hard landscape

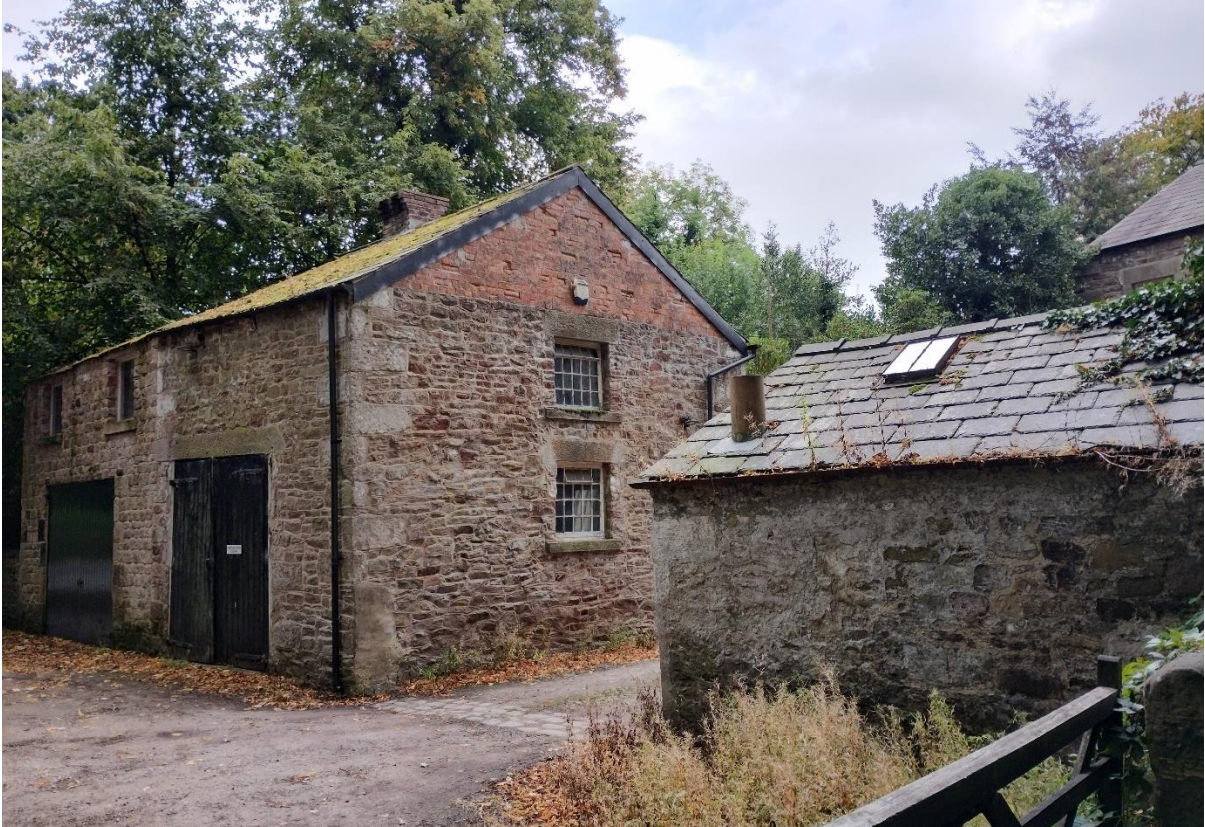
Figure 22: Outbuildings to Springfield House

- 7.4.3 Springfield House makes a good contribution to the significance of the conservation area with its well-preserved original early 19th century panelled doors, sash windows and fanlight, being set back in verdant grounds, it has an elegant character and is complemented by its the well-preserved outbuildings to the north, that reflect its relative high status.

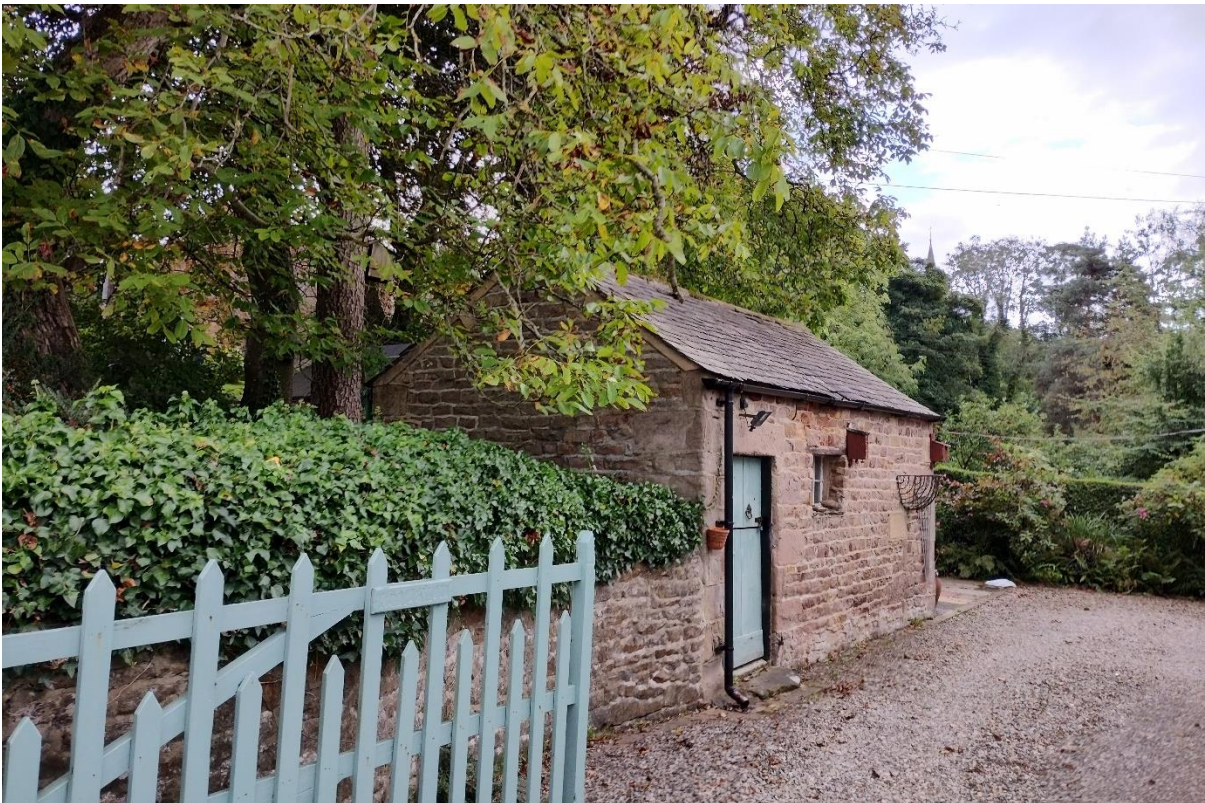
Figure 23: Outbuilding to 30 The Square

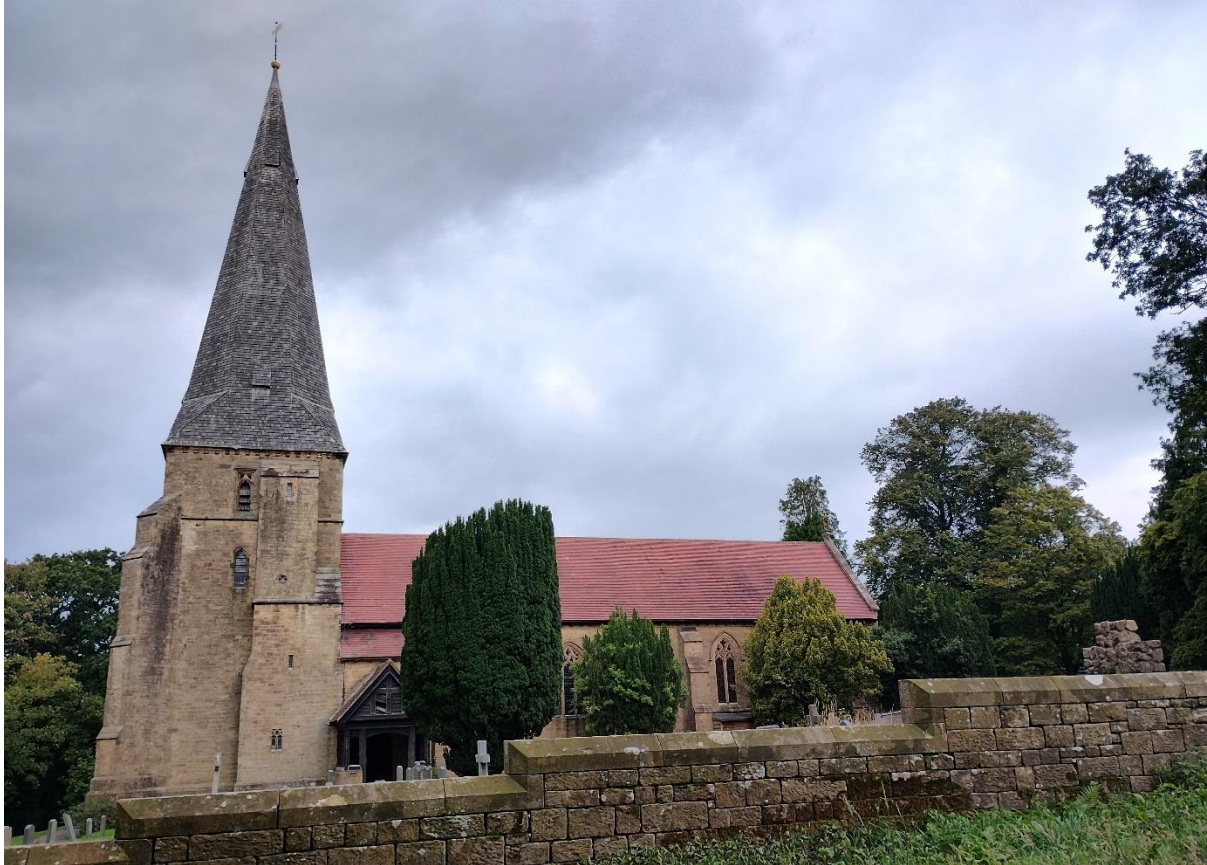
Figure 24: The Grade II listed Church of St Peter

- 7.6.4 In contrast, all three C19 places of worship employ decorative stone to great effect: distinctive rustication and gateposts at the Wesleyan Chapel, fine tooled ashlar at the Church of St Mary and St James, and Romanesque decoration at the Church of St Peter.
