# Scorton Conservation Area Appraisal and Management Plan

Draft for Consultation  
March 2025

Prepared by: **Growth**  
Lancashire Ltd

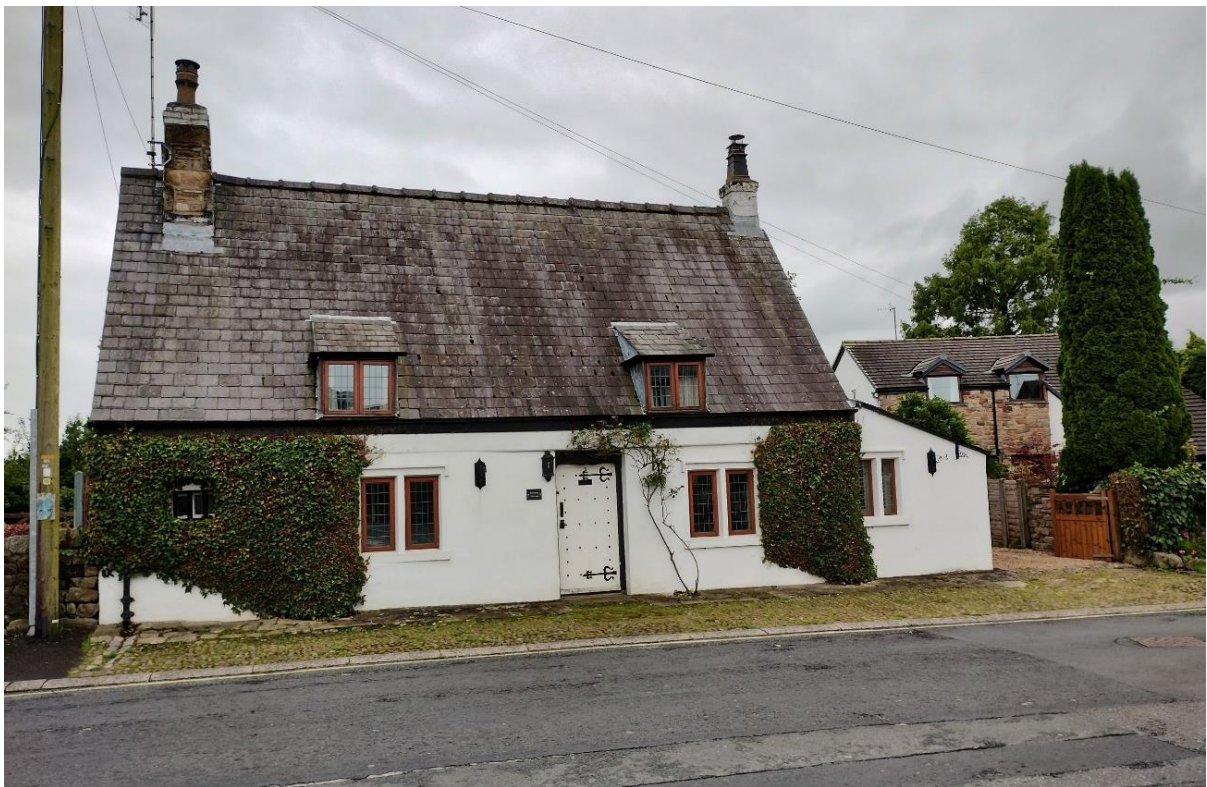
Figure 25: The Grade II listed C17 Primrose Cottage with fire window (left)

- 7.4.2 Primrose Cottage on Station Lane is notable for its preserved mullioned fire window and remains of a fire hood internally and contributes to the character of the conservation area through its rectilinear, low-lying form and dormers in the roof space. The Grade II listed Primrose Cottage, The Cottage and Grey Eaves, and The Haven, have distinctive group value, being contemporary and thus stylistically similar.

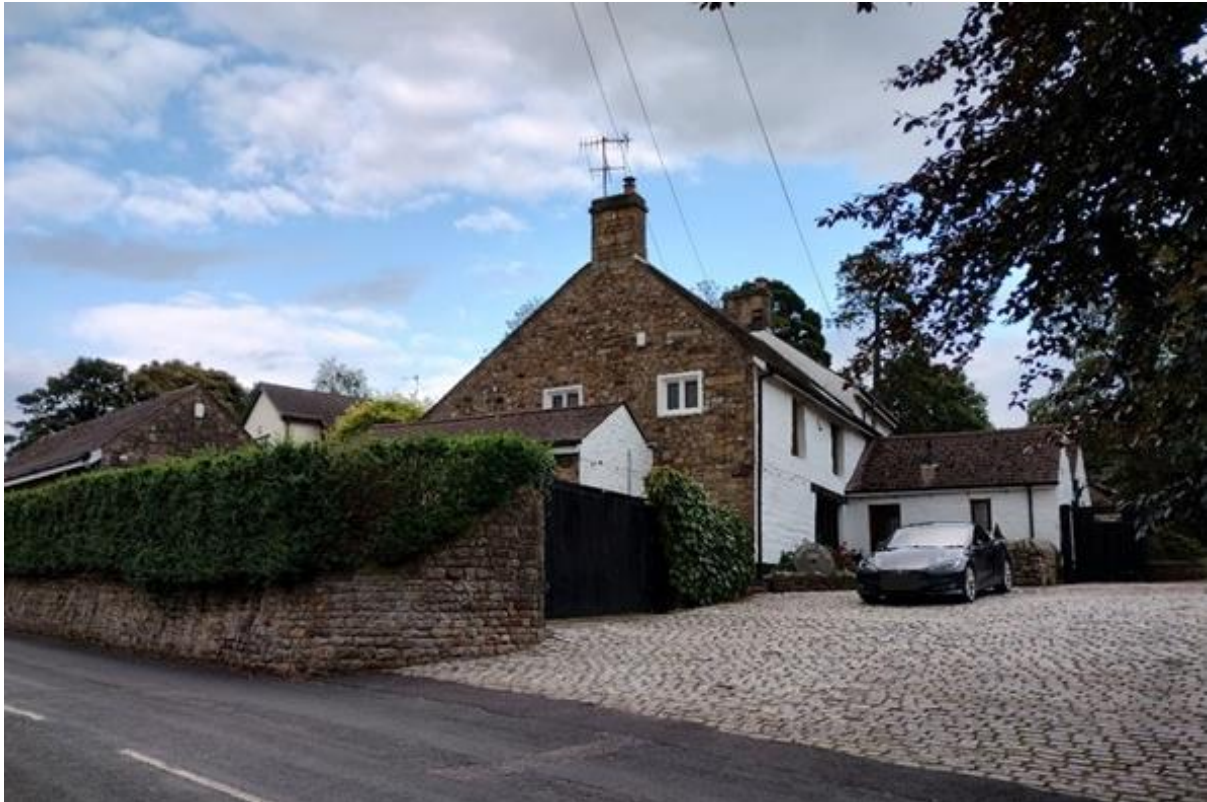
Figure 26: Circa 17th century Scorton Hall

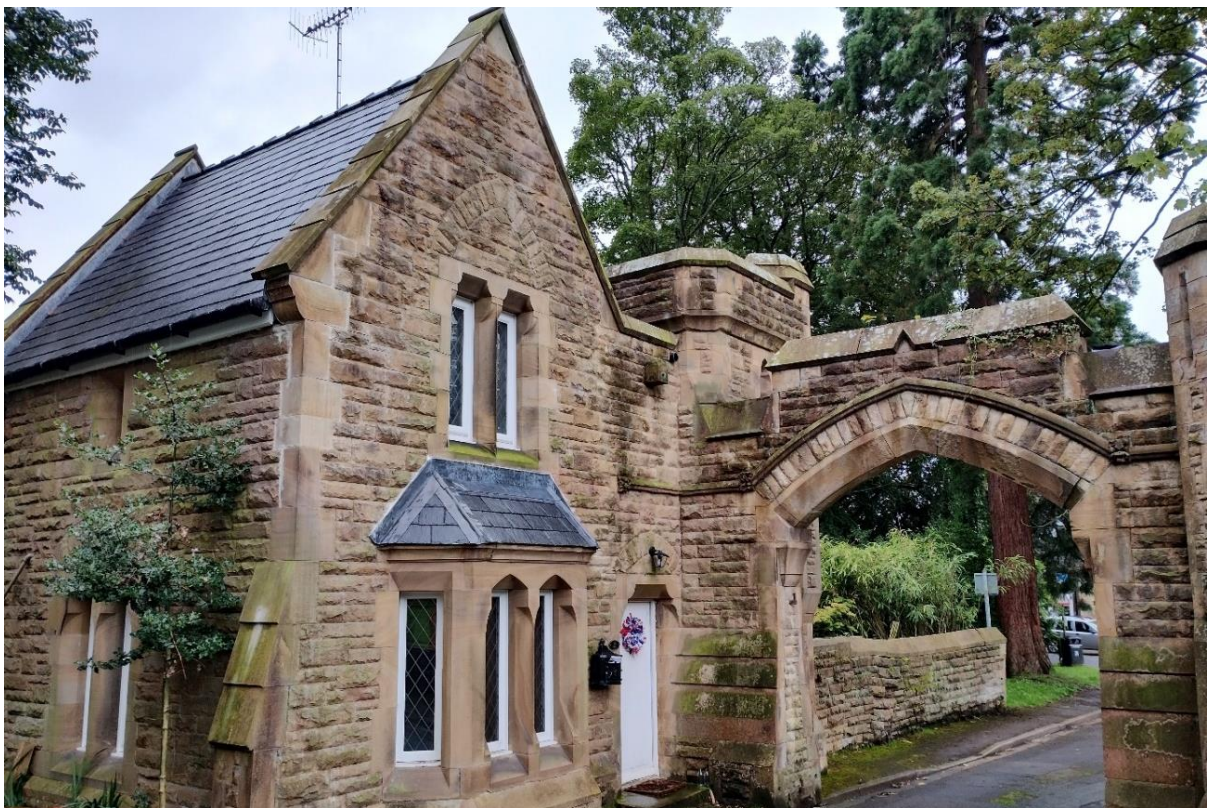
- 6.2.4 The former gatehouse to Wyresdale Hall which marks the southwestern approach from the village, emphasised by the remaining fir tree, which formed part of an avenue, provides a reminder of the presence of the hall prior to its division from the rest of Scorton by the construction of the M6.
- 6.2.5 The Barn in The Square is a focal point and landmark due to its position and scale, forming a contrast with smaller houses and emphasising the built development line.

Figure 27: The former Lodge to Wyresdale Hall

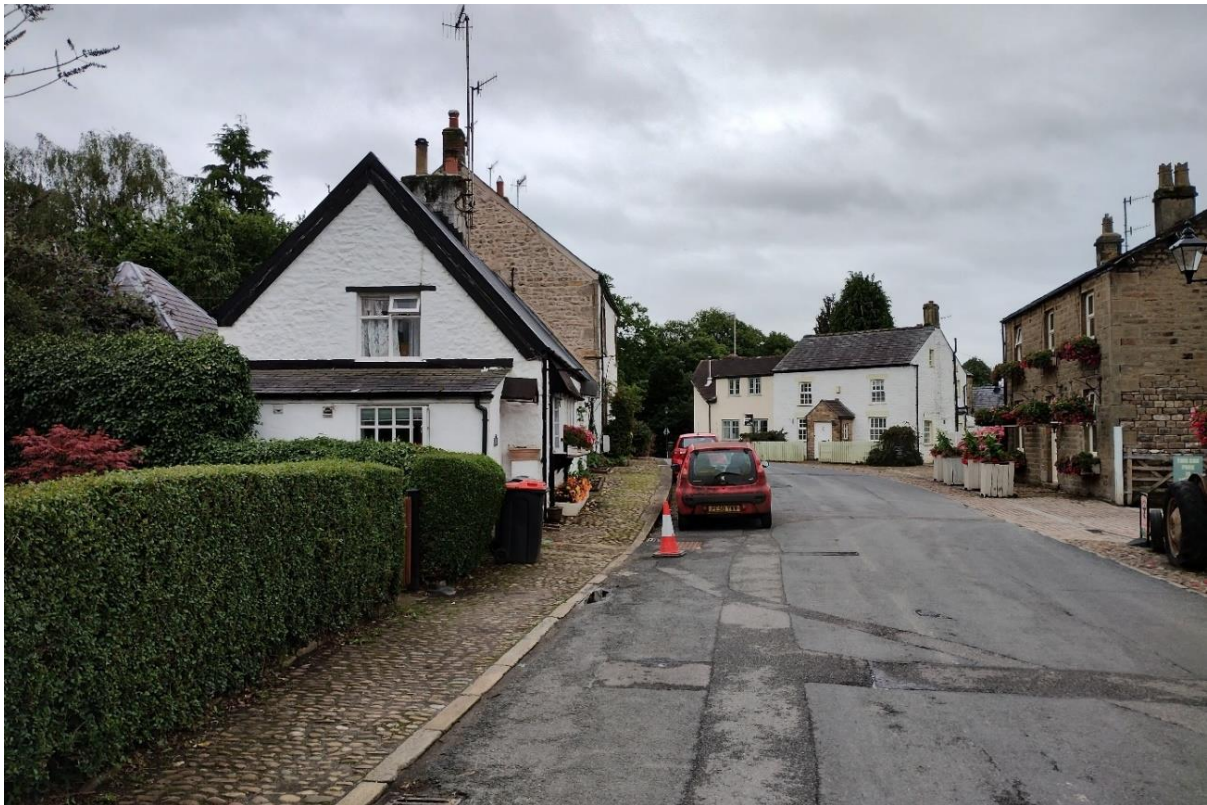
Figure 28: Formerly thatched cottages (left) with steep pitches; where chimney have been removed erodes character.

- 7.6.9 Chimneys tend to be deep and narrow, and constructed primarily of stone. They have squared or cylindrical pots, or squared bishop pots. The chimneys to the workers' cottages along Station Road are stone, those to The Square are rebuilt in red brick. Where these are removed it has eroded the uniformity of the group.

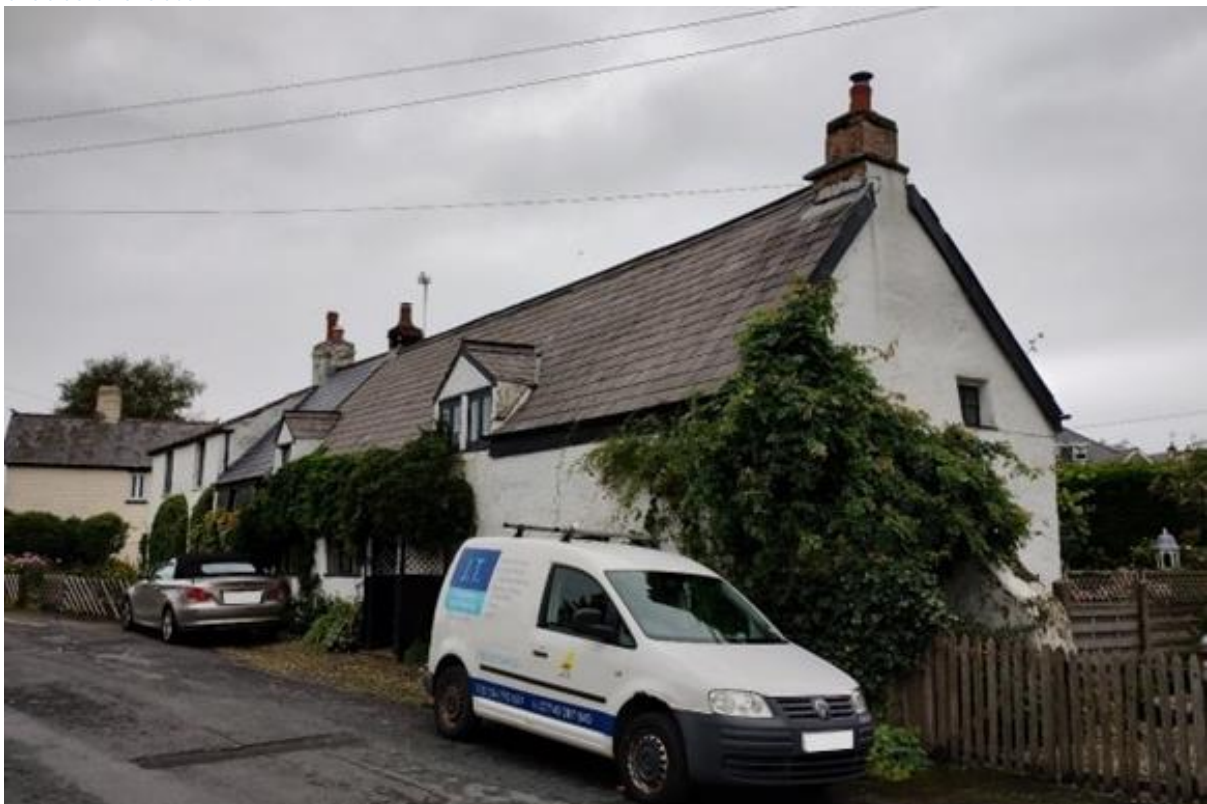
Figure 29: A formerly thatched cottage with steep roof pitches.
